TACHOMETER OPERATION AND SERVICE INSTRUCTIONS

SERVICE INSTRUCTIONS

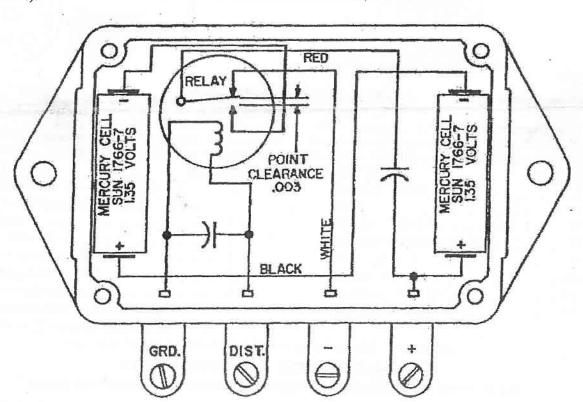
Remove cover held in place by four screws through the transmitter base. Take out the old mercury cells and snap the new cells in place as shown below. Sun Part #1766-7 is required for all, Model EB-A transmitters. (Older Model EB requires Sun Part #1766-2A with solder tab).
